**Flood Control Project Maintenance
Levee Inspections**
LMA District Cover Sheet
Spring 2008 Levee Inspection Results

Reclamation District No. 0524

Waterway		Bank	Unit Miles
Unit No. 01 San Joaquin River		Left	6.30

Levee Inspection Report By Mile - Spring 2008

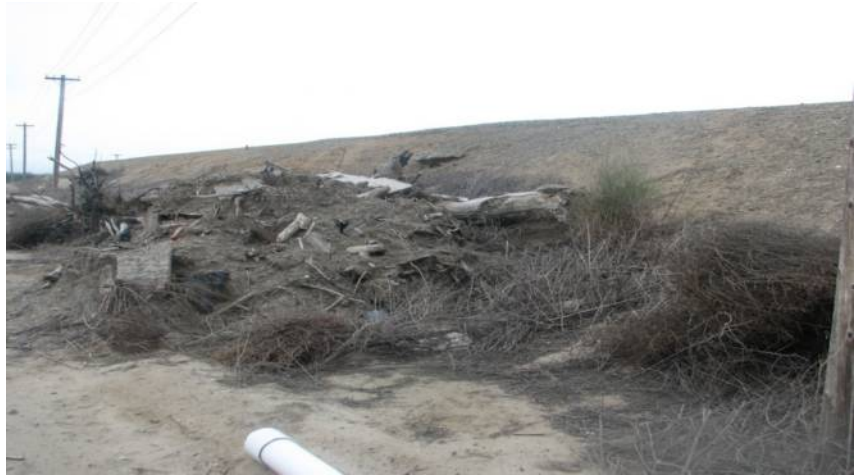
Levee Mile Report Line	4
Start Levee Mile	0.36
End Levee Mile	0.36
Location	
Category	Earthen Levee
Item	Encroachments
Garbage pile at landward toe at LM 0.36

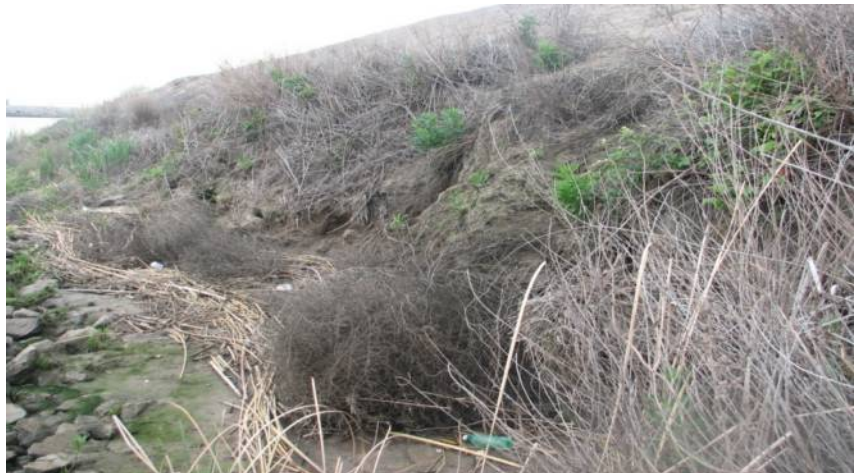
Levee Mile Report Line	5
Start Levee Mile	0.38
End Levee Mile	0.39
Location	
Category	Earthen Levee
Item	Erosion / Bank Caving
Minor erosion from LM 0.38 to 0.39

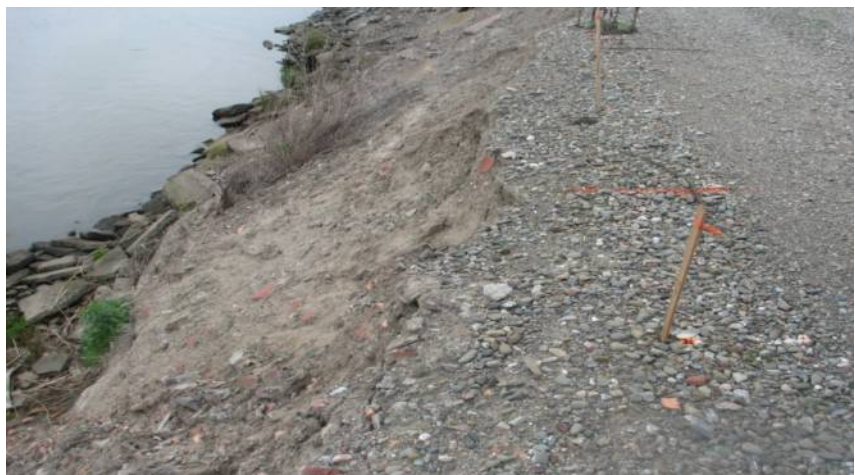
Levee Mile Report Line	7
Start Levee Mile	0.48
End Levee Mile	0.49
Location	
Category	Earthen Levee
Item	Erosion / Bank Caving
Major erosion from LM 0.48 to 0.49

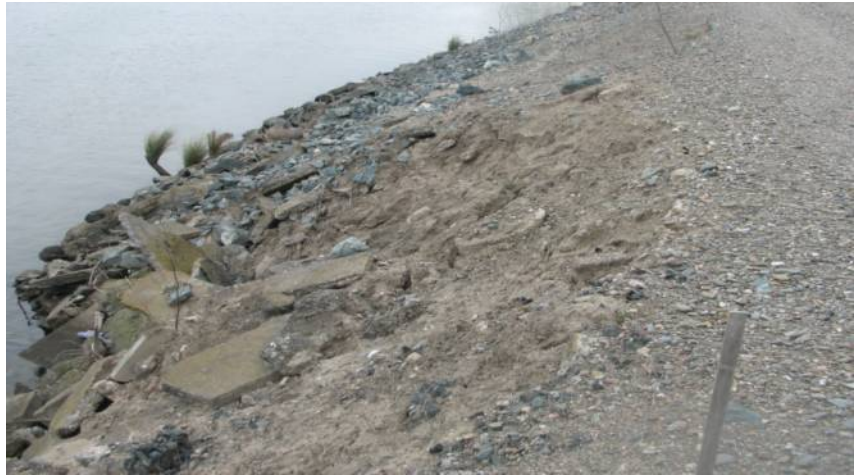
Levee Mile Report Line	8
Start Levee Mile	0.51
End Levee Mile	0.52
Location	
Category	Earthen Levee
Item	Erosion / Bank Caving
Erosion from LM 0.51 to 0.52

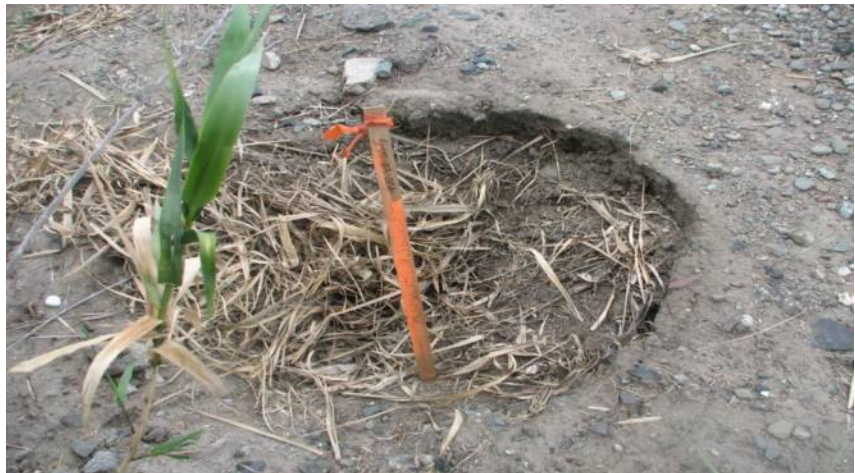
Levee Mile Report Line	13
Start Levee Mile	0.64
End Levee Mile	0.64
Location	
Category	Earthen Levee
Item	Crown Surface / Depressions / Rutting
Large hole 3 x 3 on levee crown near waterside shoulder at LM 0.64

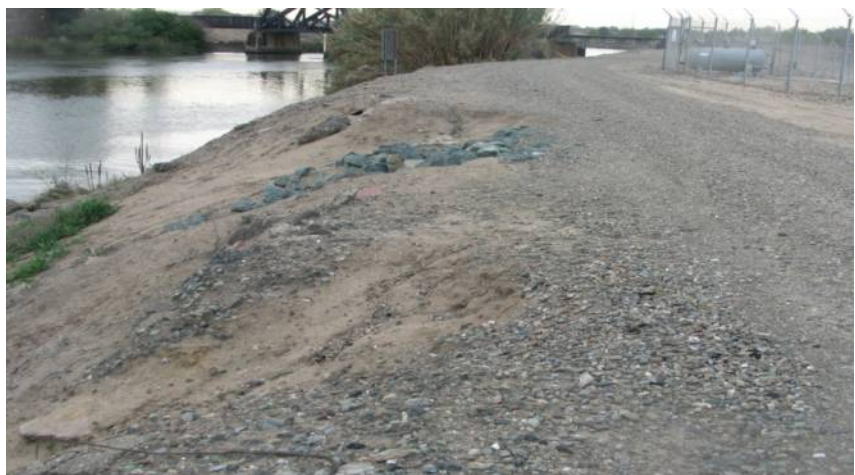
Levee Mile Report Line	14
Start Levee Mile	0.65
End Levee Mile	0.66
Location	
Category	Earthen Levee
Item	Erosion / Bank Caving
Erosion from LM 0.65 to 0.66

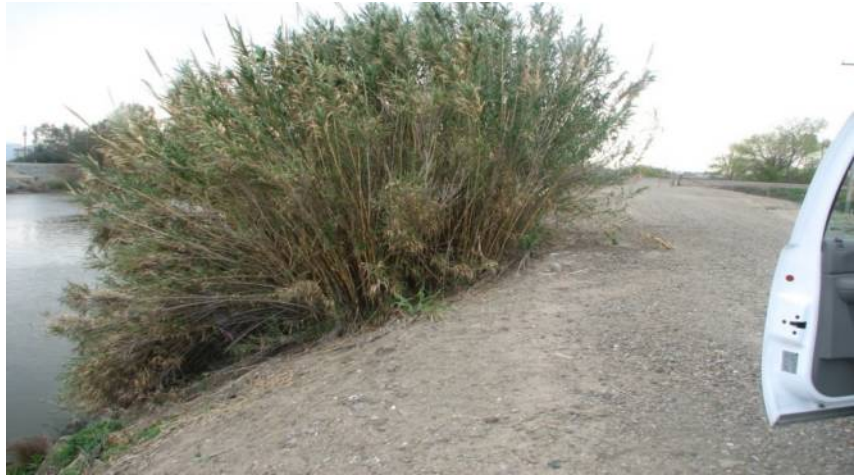
Levee Mile Report Line	15
Start Levee Mile	0.68
End Levee Mile	0.68
Location	
Category	Earthen Levee
Item	Vegetation
Bamboo on waterward slope at LM 0.68

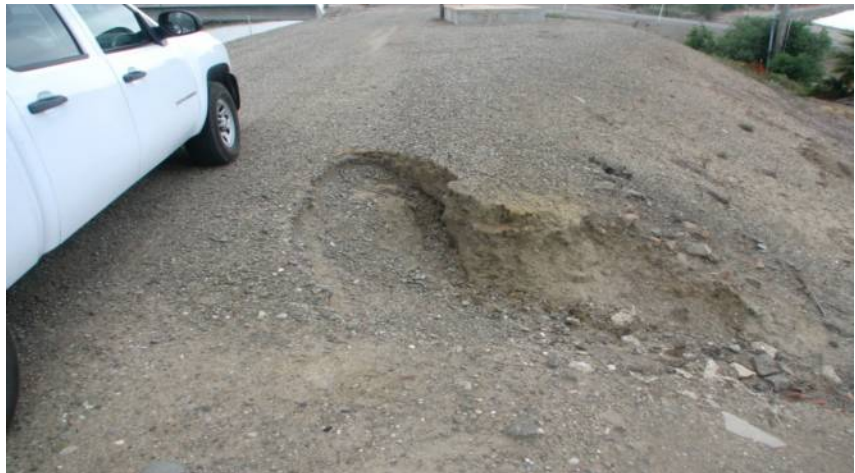
Levee Mile Report Line	18
Start Levee Mile	1.09
End Levee Mile	1.09
Location	
Category	Earthen Levee
Item	Slope Stability
Landward slope damage at LM 1.09

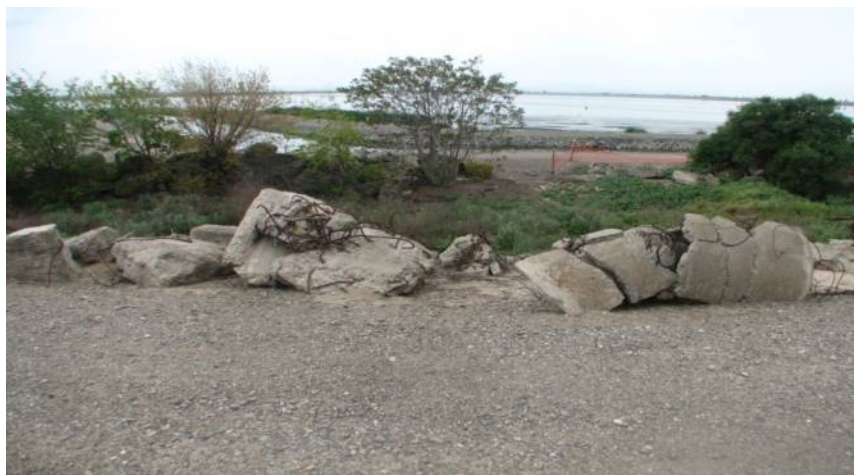
Levee Mile Report Line	20
Start Levee Mile	1.25
End Levee Mile	1.25
Location	
Category	Earthen Levee
Item	Encroachments
Concrete rubble with rebar on landward shoulder at LM 1.25

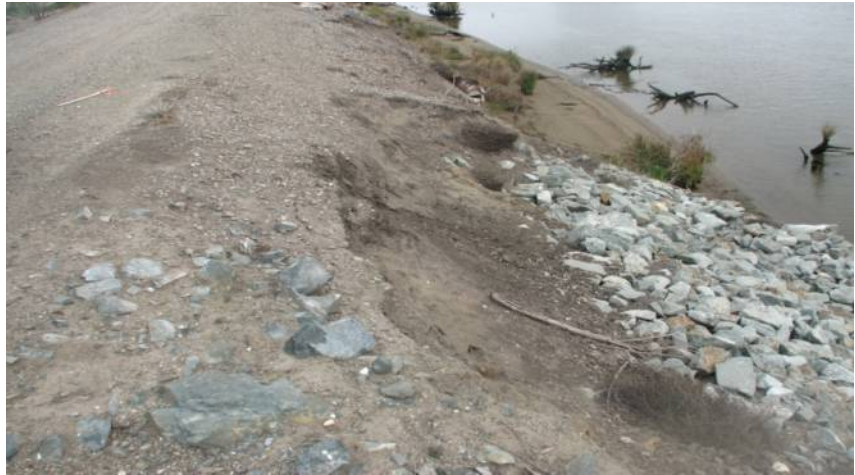
Levee Mile Report Line	21
Start Levee Mile	1.32
End Levee Mile	1.33
Location	
Category	Earthen Levee
Item	Erosion / Bank Caving
Erosion from LM 1.32 to 1.33

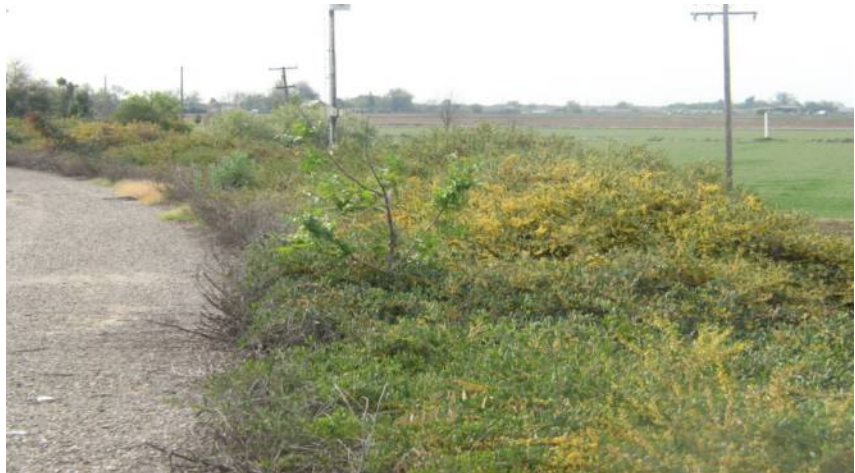
Levee Mile Report Line	23
Start Levee Mile	1.56
End Levee Mile	1.74
Location	
Category	Earthen Levee
Item	Encroachments
Overgrown landscaping on landward slope from LM 1.56 to 1.74

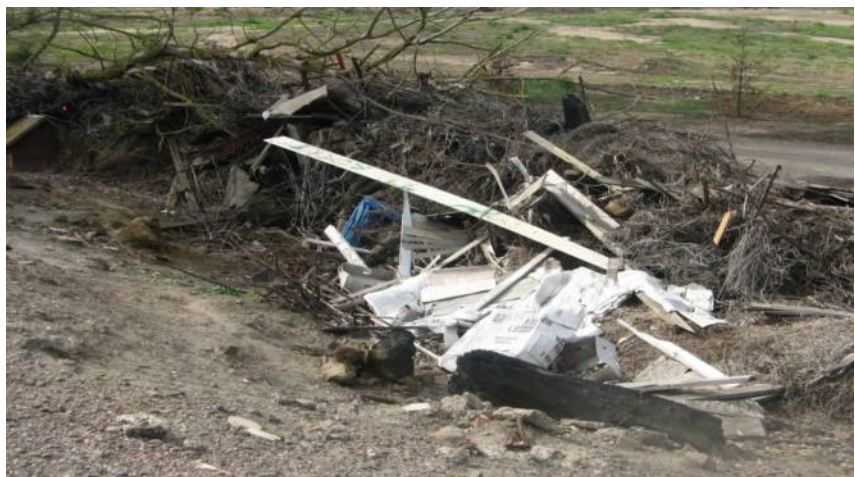
Levee Mile Report Line	28
Start Levee Mile	1.75
End Levee Mile	1.76
Location	
Category	Earthen Levee
Item	Encroachments
Garbage on landward toe from LM 1.75 to 1.76

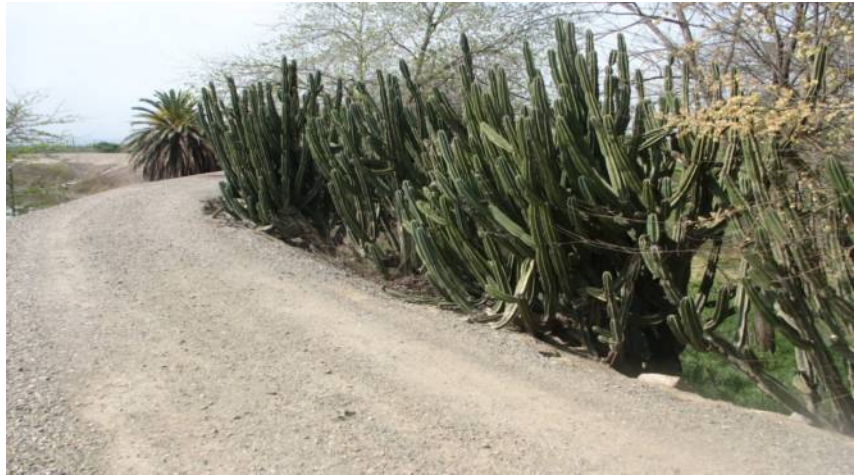
Levee Mile Report Line	46
Start Levee Mile	2.78
End Levee Mile	2.79
Location	
Category	Earthen Levee
Item	Encroachments
Landscaping (Cactus) on landward slope from LM 2.78 to 2.79

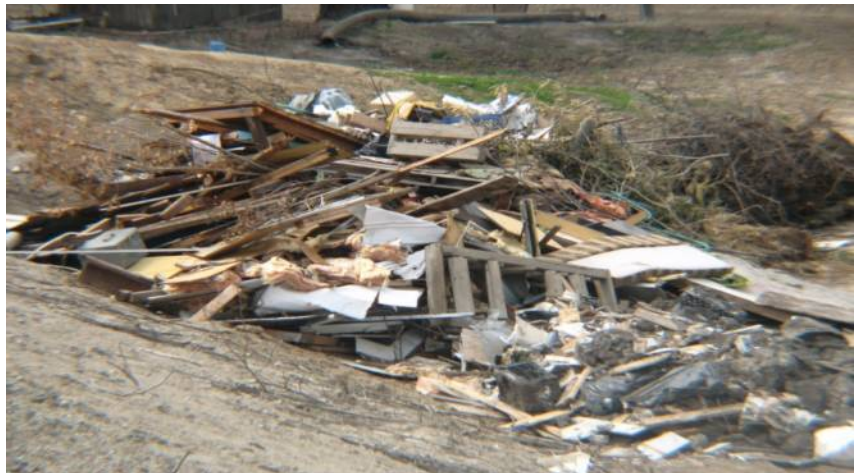
Levee Mile Report Line	63
Start Levee Mile	4.05
End Levee Mile	4.05
Location	
Category	Earthen Levee
Item	Encroachments
Garbage at landward toe at LM 4.05

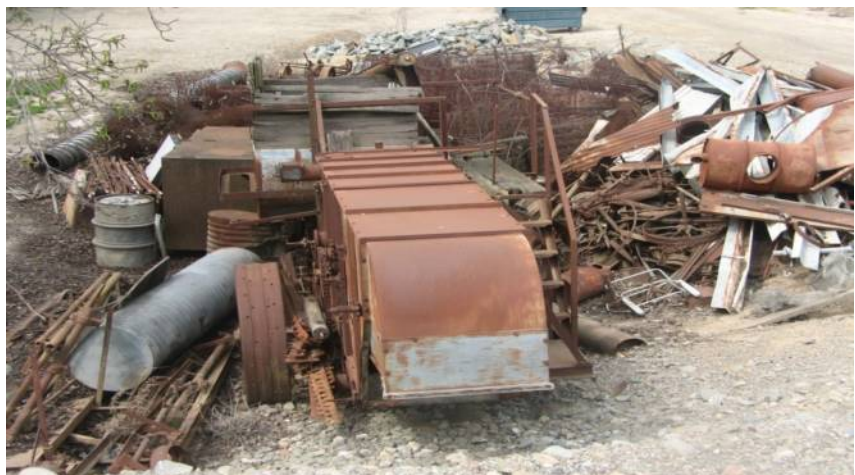
Levee Mile Report Line	67
Start Levee Mile	4.64
End Levee Mile	4.64
Location	
Category	Earthen Levee
Item	Encroachments
Garbage at landward toe next to ramp at LM 4.64

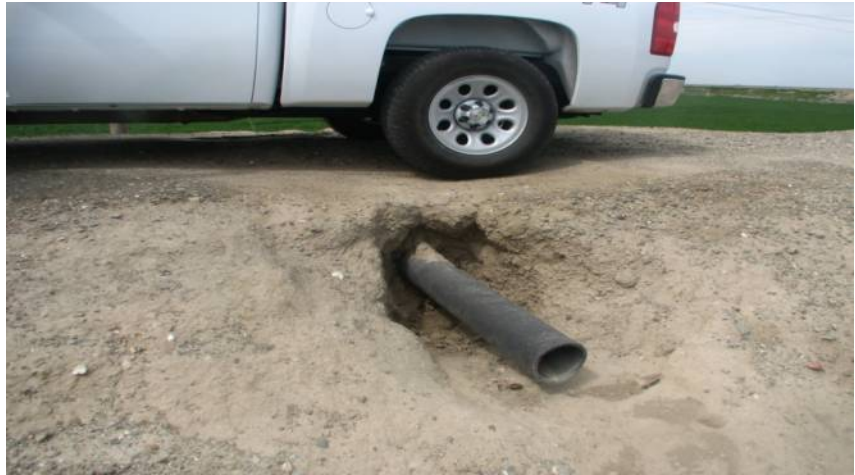
Levee Mile Report Line	71
Start Levee Mile	5.87
End Levee Mile	5.87
Location	
Category	Earthen Levee
Item	Encroachments
Abandoned pipe at LM 5.87 wateside view

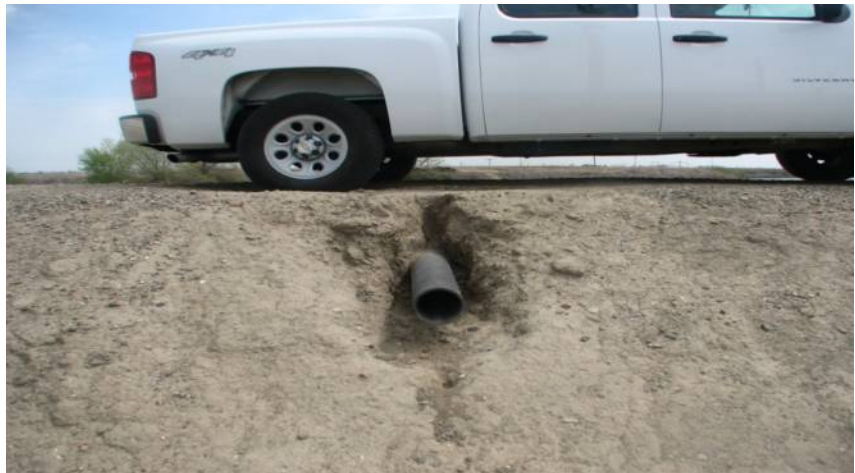
Levee Mile Report Line	71
Start Levee Mile	5.87
End Levee Mile	5.87
Location	
Category	Earthen Levee
Item	Encroachments
Abandoned pipe at LM 5.87 landside view

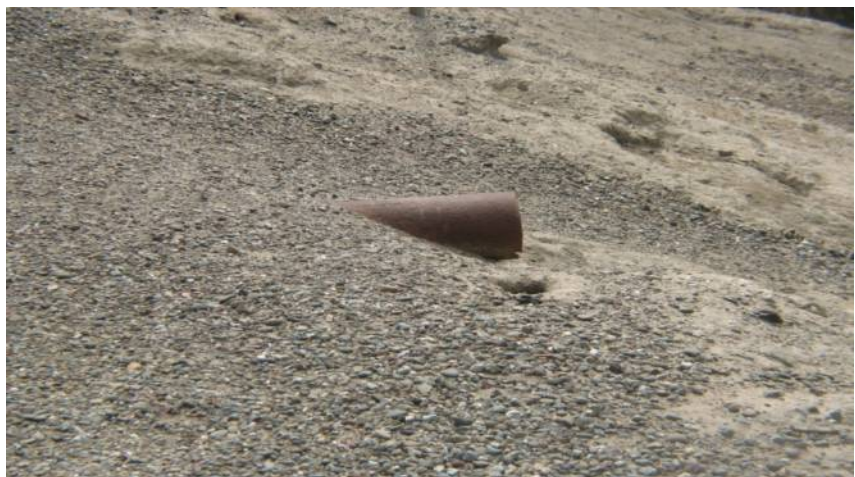
Levee Mile Report Line	73
Start Levee Mile	5.92
End Levee Mile	5.92
Location	
Category	Earthen Levee
Item	Encroachments
Abandoned pipe at LM 5.92 wateside view

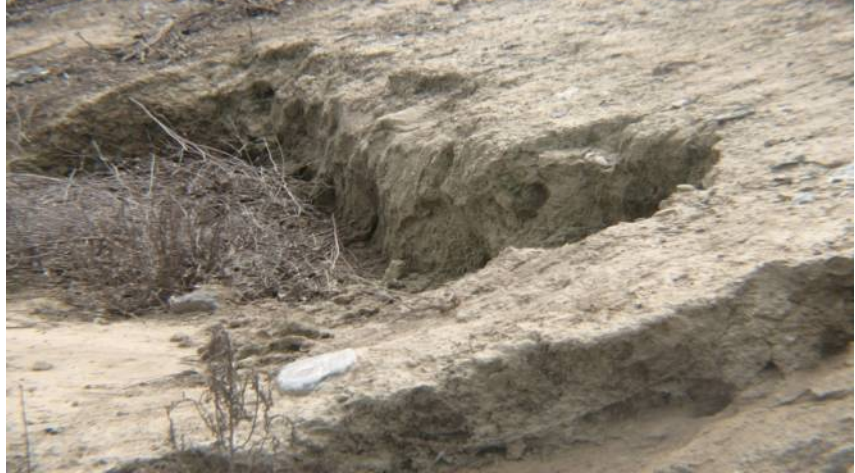
Levee Mile Report Line	74
Start Levee Mile	5.92
End Levee Mile	5.92
Location	
Category	Earthen Levee
Item	Erosion / Bank Caving

Erosion at waterward toe at LM 5.92
